The safety benefits provided by ADAS systems depend on accurate installation and precision calibration. Those requirements pose some pitfalls for the unwary fleet engineer, particularly where windscreen-mounted cameras are concerned, finds Lucy Radley

Advanced Driver Assistance Systems (ADAS) such as lane departure warning systems (LDWS) and advanced emergency braking systems (AEBS) have been compulsory on new trucks for some years now, and the number of currently optional extensions to this is rapidly growing.

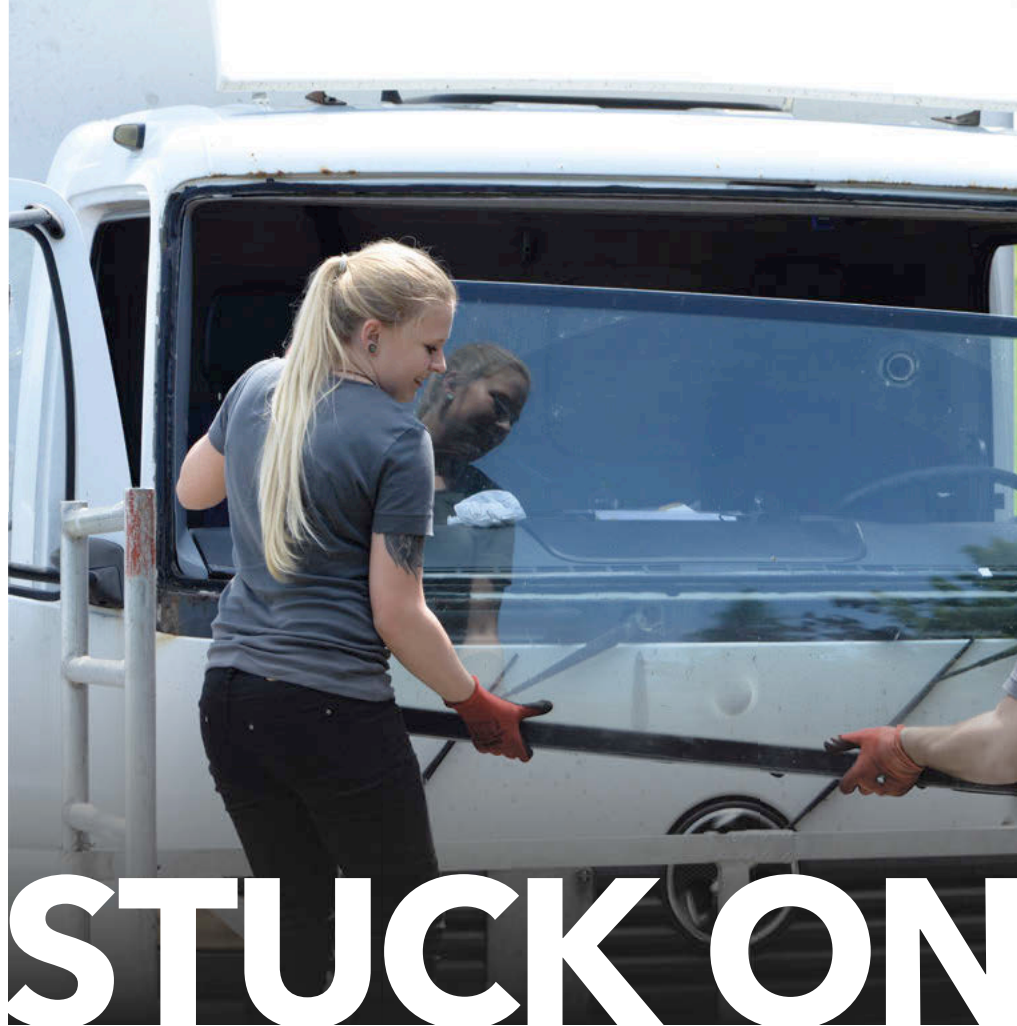
STUCK ON

The most obvious sign of a problem is when the camera bracket - which should not be reused - has been reattached to the windscreen using materials such as double-sided tape or silicone (pictured

above, middle). "These guys are doing what they think is the right thing and sticking the camera back in the same place," McGrath says. "What they're not realising is that the camera needs to be centred exactly: the roll angle of the camera is critical, so left and right turns must be perfectly calibrated. The camera looks about 100m into the distance, so if it's out of kilter it's potentially looking in the wrong lane, and may not see a collision risk ahead."
